# Evaluation of MRI Artifact in some selected centers in Kano Metropolis, Nigeria

**Study aims:** The study aimed at evaluating MRI artifact in some selected centers in Kano metropolis, Nigeria.

A descriptive cross-sectional study was conducted involving both prospective and retrospective phases across three centres; Centre A (0.3T Hitachi model of MRI scanner), Center B (0.2T GE, KC-2196 model of MRI scanner) and Centre C (1.5T Siemens, signal creator model of MRI scanner) in Kano metropolis, Nigeria from March 2019 to November 2019. There were 5 functional MRI scanners at the study, but only 3 agreed to participate in the study. An ethical approval to conduct the study was obtained from the Human Research and Ethics Committee of the Kano State Ministry of Health. The data was obtained from the procedures performed in the centers during the study period and the achieved. The data capture sheet was developed as an instrument of data collection instrument; the instrument was validated by an experienced senior colleague, the variables contained include; the name of the hospital, the type of the artifact encountered the region of the body where the variable was encountered and the e

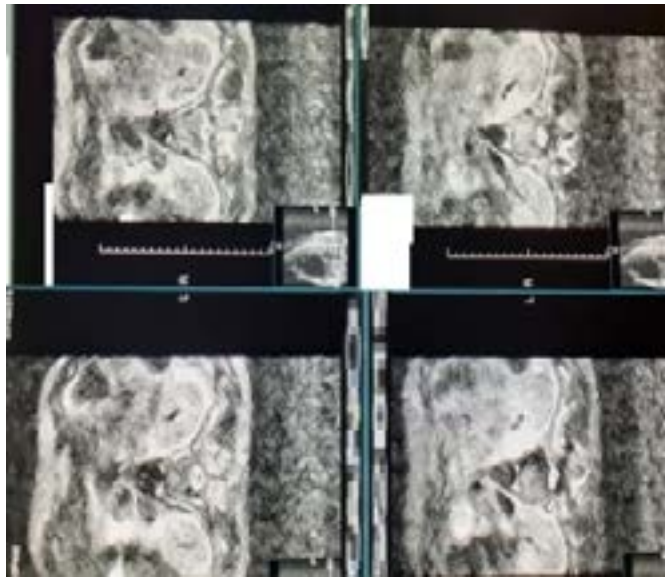
are also associated with involuntary movement. In motion induced artifact the spin changes the frequency and therefore also phase compared to its original position. When the image is reconstructed, the position of the signal is put in the wrong place in the image. Random motion during the imaging sequence generally results in a blurring of the image, periodic motion produces ghost images. The correction strategies that can be used to eliminate or avoid such types of artifact include; breath holding, sedation, anesthesia, immobilization, signal averaging, breath triggering, and gradient moment nulling. The findings of the study also show that, the second most frequently occurring artifact is wrap-around artifact 15 (21.4%) as shown in Table 4. However, 14 (20%) was encountered in series acquired with 0.3T Hitachi model of the MRI scanner and were all associated with thoracic as shown in Table 1. The remaining 1 (1.4%) was encountered in series acquired with 1.5T Siemens, signal creator model of the MRI scanner and was associated with the knee joint as shown in table 2.

**Figure 2:** Motion induced artifact seen on lumbar spine MRI.

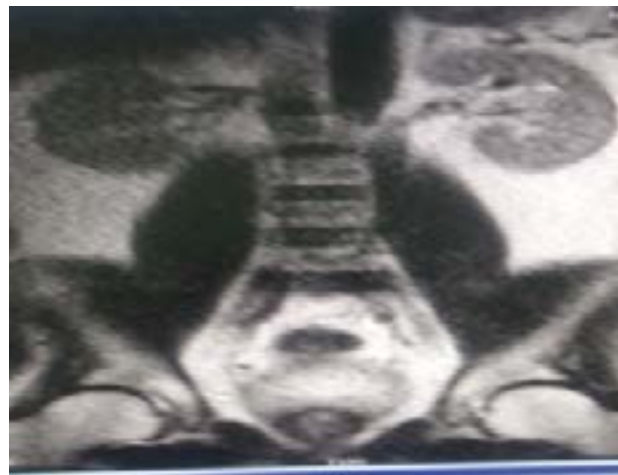
It was encountered in series acquired with 1.5T Siemens scanner only as shown in Table 1, and was found to be associated with lumbar spine only. It also has a negative effect on image quality because 2 (2.9%) caused repeat of the examination as shown in Table 5. It is manifested as bright or dark outlines at fat-water interfaces. The chemical shift artifact can be corrected using an MRI device with a weaker magnetic field; use of the higher permeability receiver, selection of a larger matrix, phase TE or “spin-echo” (SE) sequences; larger gradient and special pulse sequences, such as fat saturation or inver-

**Figure 3:** Chemical shift artifact seen on lumbar spine MRI

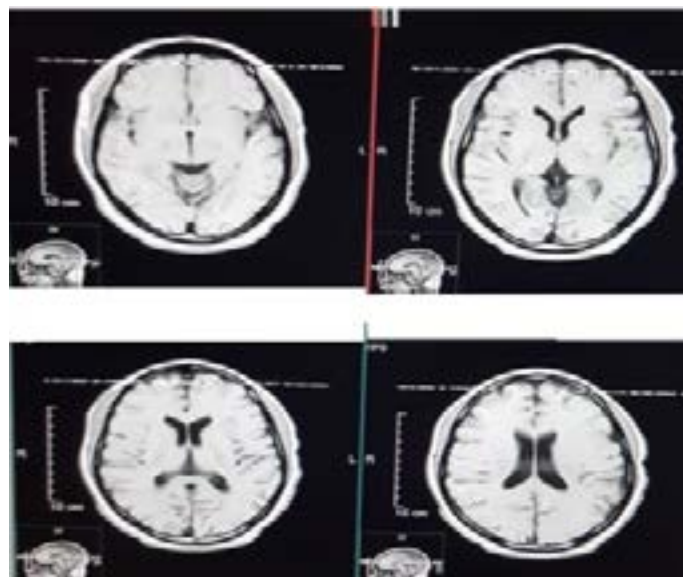
Frequency artifact constituted 13 (18.6%) of the total artifacts encountered from the three centers as shown in table 4. However, 11 (15.7%) was encountered in images acquired with 0.3T Hitachi model of MRI scanner, 7 (10%) associated with brain MRI scan and 4 (5.7%) with thoracic as shown in Table 1. The remaining 2 (2.9%) was encountered in images acquired with 1.5T Siemens, signal creator model of the MRI scanner and was associated with lumbar spine as shown in Table 2. Frequency-induced artifact also has a negative effect on image quality because 8 (11.4%) caused repeat of the examinations as shown in Table 5. The frequency-induced artifacts are caused by “dirty” frequencies, faulty electronics, external transmitters, RF-cage leak, non-shielded equipment in the scanner room, metal in the patient, or when the door to the scanner room is left open can generate “dirty” frequencies. This usually requires an engineer to solve this kind of artifact, although, the door to the scanner room can be closed

**Figure 4:** Frequency artifact as a result eye motion during acquisition of brain MRI.

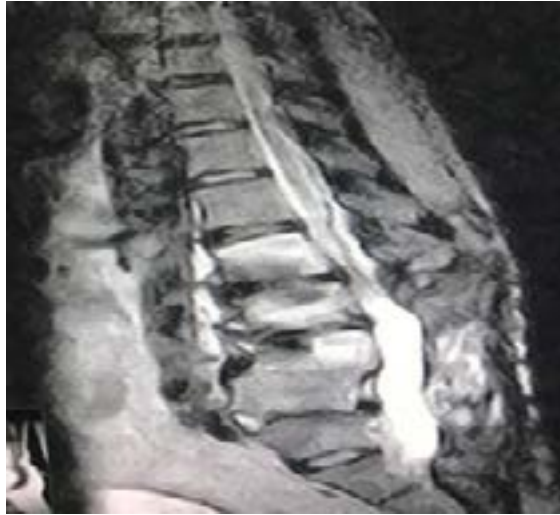
The metal-induced artifact constituted 3 (4.3%) of the total series, 1 (1.4%) from each of the three scanners as shown in Tables 1, 2 and 3, two of the artifacts were associated with brain scan and one with lumbar spine as shown in Table 4. It has a minimal effect on image quality because only 1 (1.4%) caused a repeat of an examination. In metal-induced artifact geometric distortion of the image occurs which lead to the disappearance of the structures. These types of artifact can be corrected using techniques, such as flow compensation or cardiac triggering; to minimize or eliminate motion related artifacts. The removal of ferromagnetic foreign bodies; application of smaller voxel; shortening the re-

**Figure 5:** Metal induced artifact seen on lumbar spine MRI on patient with known inherent metallic implant

sponse time; use of short echo time (TE); amplification of the receiver permeability; use of SE (especially fast SE) sequences and the MRI device with a weaker magnetic field are also some of the correction strategies<sup>7</sup>. Only 1 (1.4%) of the series was associated with spike artifact, it was obtained by 1.5T Siemens scanner and was associated with a brain scan. However, it has no negative effect on image quality because it didn't cause a repeat of the examination. In spike artifact, loss of single data points or data lines in the acquisition process due to spike forms external interfering signals or errors in the signal processing which can lead to a variable degree of artifact, sometimes showing a “crisscross” or “herringbone” pattern<sup>9</sup>.

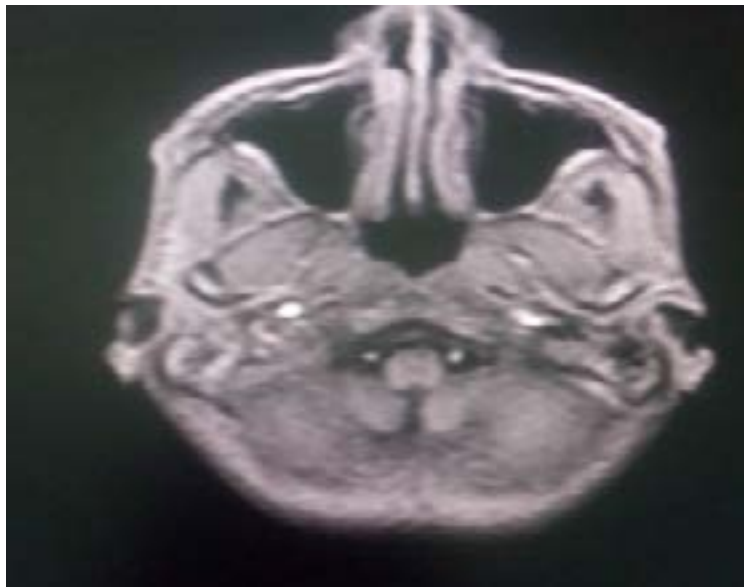
**Figure 6:** Spike artifact seen as diagonal line patterns on the image when observe carefully.

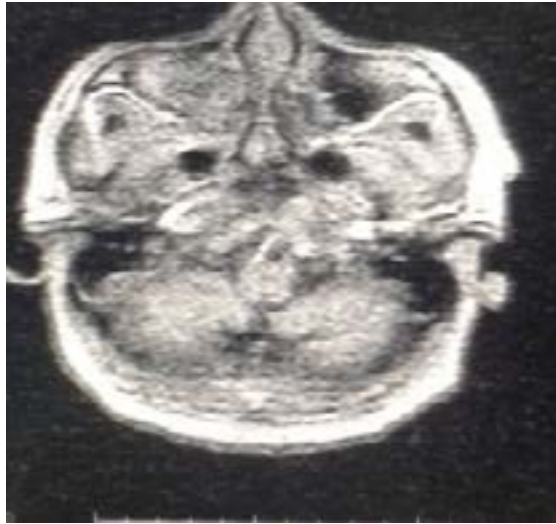
sion recovery and also decreasing the voxel size can be employed. The susceptibility artifact is seen in 4 (5.7%) of the series. However, 3 (4.3%) was encountered in series acquired with 1.5T Siemens scanner, 1 (1.4%) with 0.2T GE, KC-2196 model of the MRI scanner and both were associated with brain scan as shown in table 2 and 3. Fortunately, none causes repeat of the MRI examination as shown in Table 5, this shows little effect on the image quality. It usually appears as light and dark spots with a spatial distortion in the neighboring anatomic structures.

**Figure 7:** Susceptibility artifact seen on coronal brain MRI.
